Article #4 ~ Main Issues at Mount Nansen Mine

What are the Main Issues of Concern at Mount Nansen?

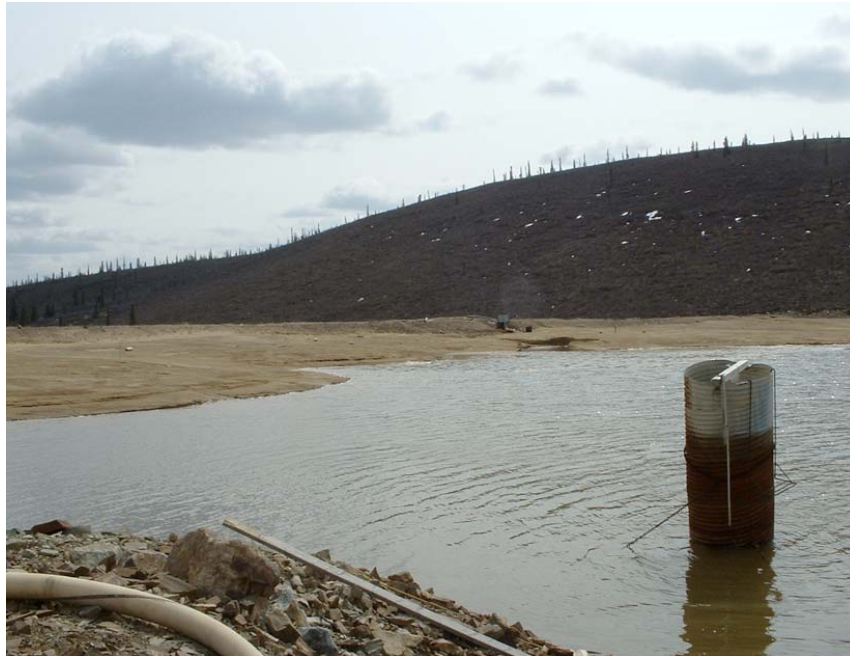
a) Tailings: The tailings are the biggest concern at Mount Nansen. Tailings are like fine sand, containing metals and some chemicals that were added in the milling process. The tailings are stored in ponds, held behind a dam. The valley floor and sides are made of sand. When the valley floor is frozen due to permafrost, water is prevented from passing into the ground beneath. When these areas thaw it is possible for water from the tailings pond to seep through and under the dam.
